# **Pentium<sup>®</sup> II Processor Specification Update**

Release Date: December 1997

Order Number: 243337-008

The Pentium<sup>®</sup> II processor may contain design defects or errors known as errata which may cause the product to deviate from published specifications. Current characterized errata are documented in this Specification Update.

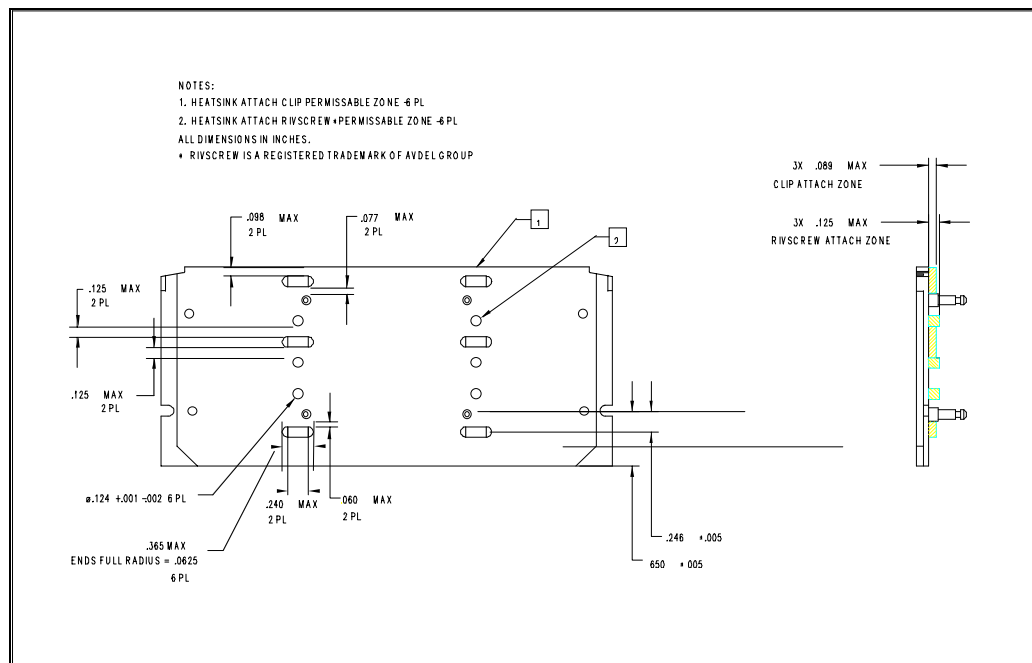
**Figure 12. Heatsink Attachment Mechanism Design Space**

A change to the attach mechanism specification is provided below. The original specification for clearance of heatsink attach solutions is provided in Section 4.3 (and Figure 23 and Figure 24) in the *Pentium® II Processor at 233 MHz, 266 MHz and 300 MHz* datasheet. Figure 11 shows the revised maximum specifications for heatsink clip and RivscREW\* attach mechanism designs. All heatsink clip and RivscREW attachment solutions must remain within the respective maximum “permissible” zone as detailed in Figure 11.

The thermal plate shown in Figure 11 is used to portray the heatsink attach mechanism design space for the future Slot 1 processors. However, the maximum “permissible” design space is also valid for both the current Pentium II and future Slot 1 processors.

Please review the proposed specifications to guarantee compatibility with existing Pentium II and future Slot 1 processor heatsink attachment solutions. Note that the required heatsink attachment solution space should not exceed the maximum proposed design space while installed or during the installation and removal procedure.
